Artifacts in MRI

Artifact: Any irregularity noted in an MR image which is related to the imaging process rather than to an anatomical or physiological abnormality.

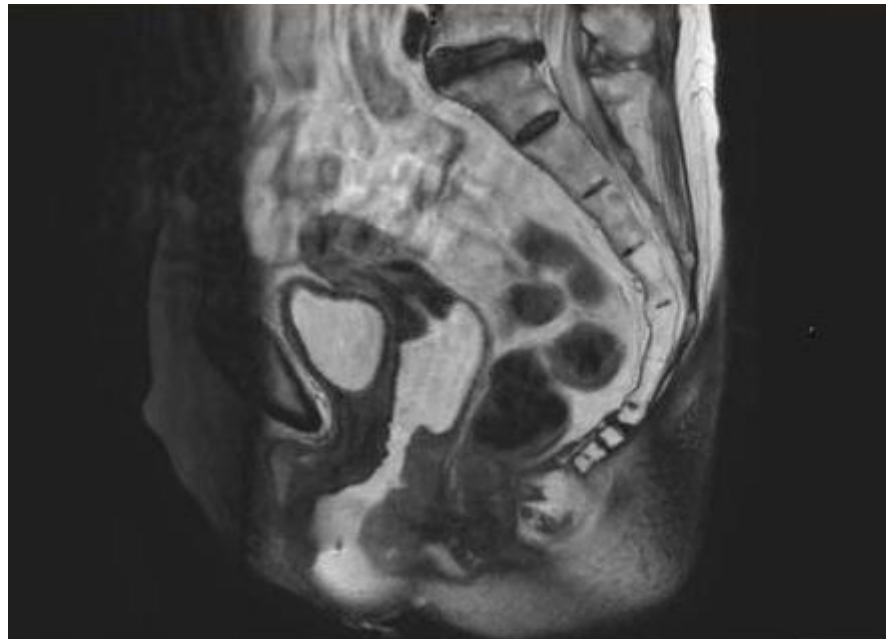
Peristalsis Motion Artifacts

Solution for Peristalsis motion artifacts:

- Give an Anti-peristaltic drug (prescribed by referring physician)
- Patient preparation (NPO, Nothing Per Orem)
- Strap the patient tight
- MultiVane

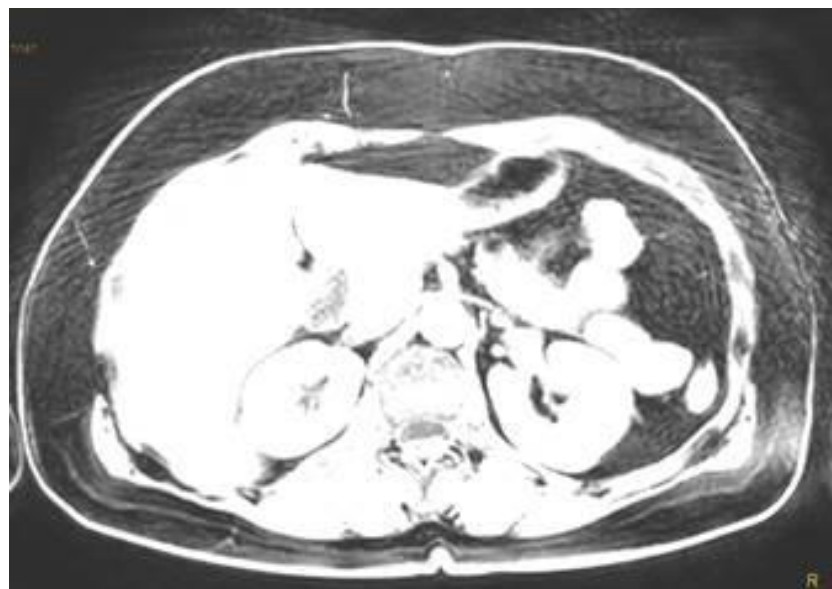
Low MultiVane percentage

- Causes streaking artifacts

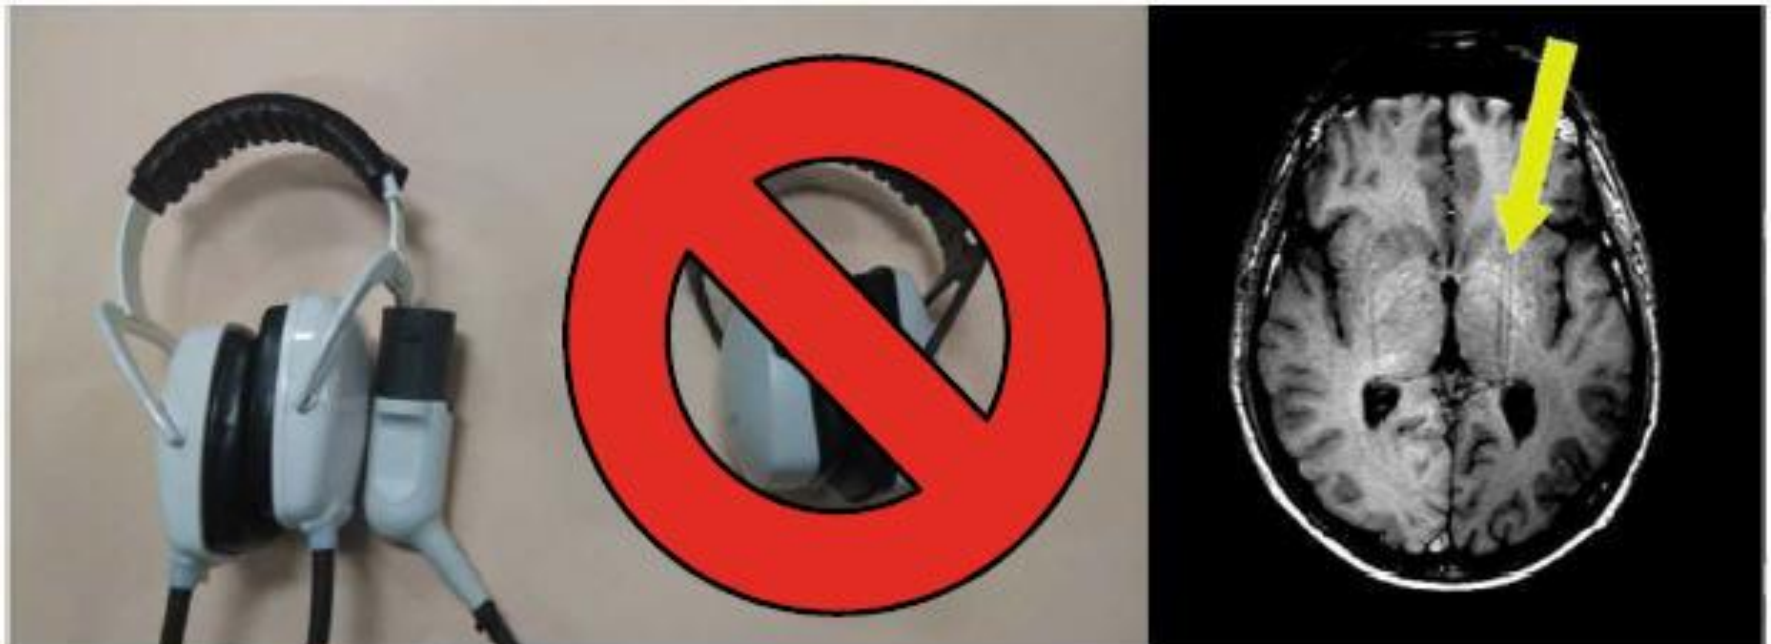
Proton signal in passive headset

- Advice has always been to use only the patient headset that connects to system.
- Can fold into brain when SENSE is applied.

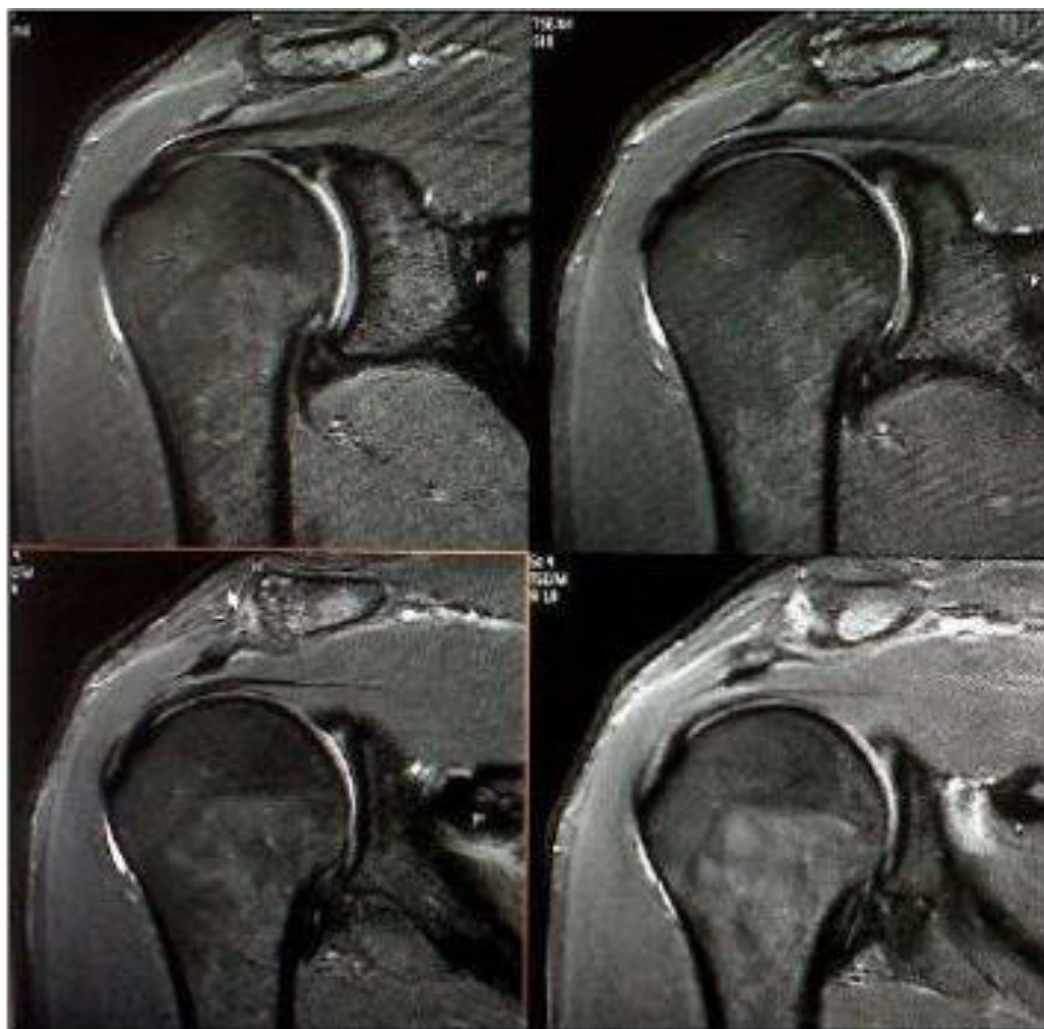
Spikes

Many sources possible

In this case, caused by a loose pin in coil.

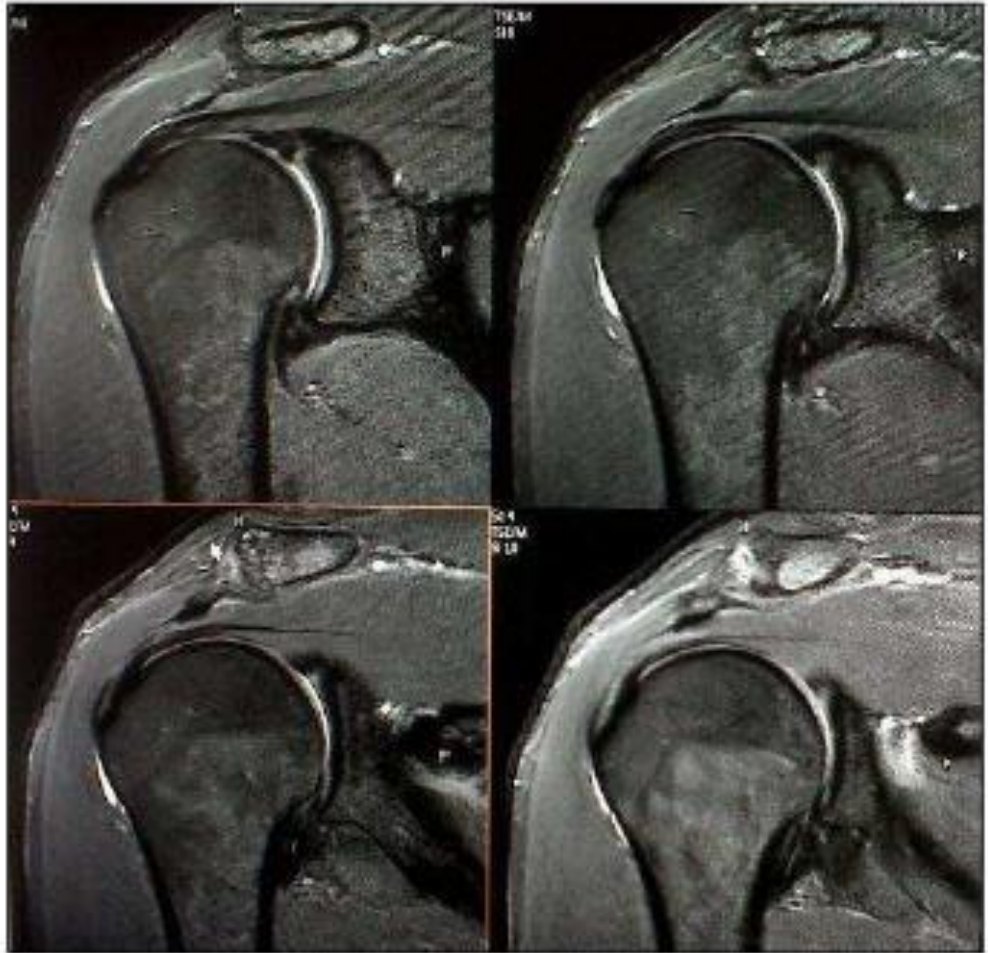
Spikes are caused by a 'bad' data point in k-space, due to hardware or environmental influences, leading to:

- Zebra stripes
- Noise
- Data point artifact

In this example, spikes from gradient coil →

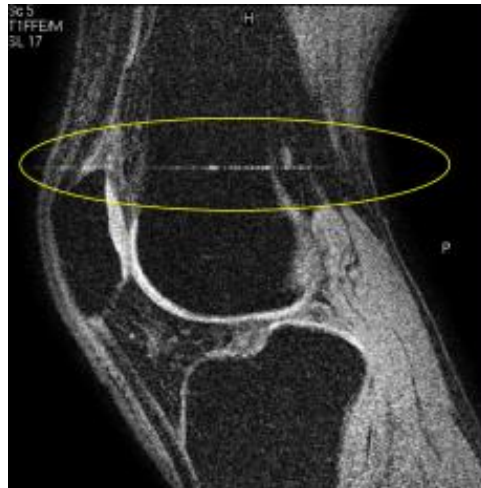
RF Interference

- RF disturbance in the scan room can cause:
 - Single dots
 - Line artifacts

Common causes:

- RF door open
- Poor integrity of RF room
- 3rd party equipment
- Broken light bulb

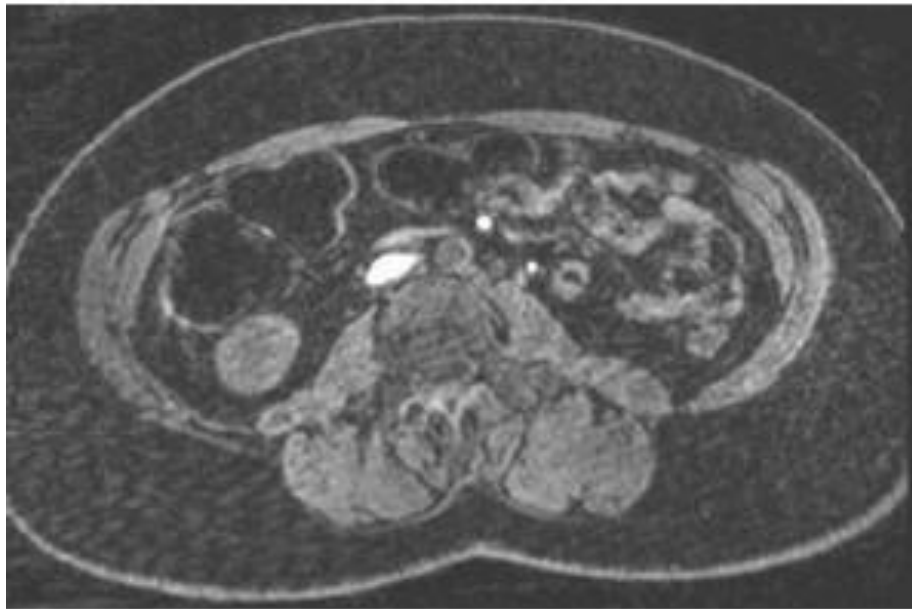
Spikes

Humidity in the scan room too low.

- Leads to arcing and sparking across components.
- Can appear as low signal to noise, linear artifacts, and grids.

- Appeared as line artefact
- Occurred with all coils
- Affected one slice
- Intermittent occurrence

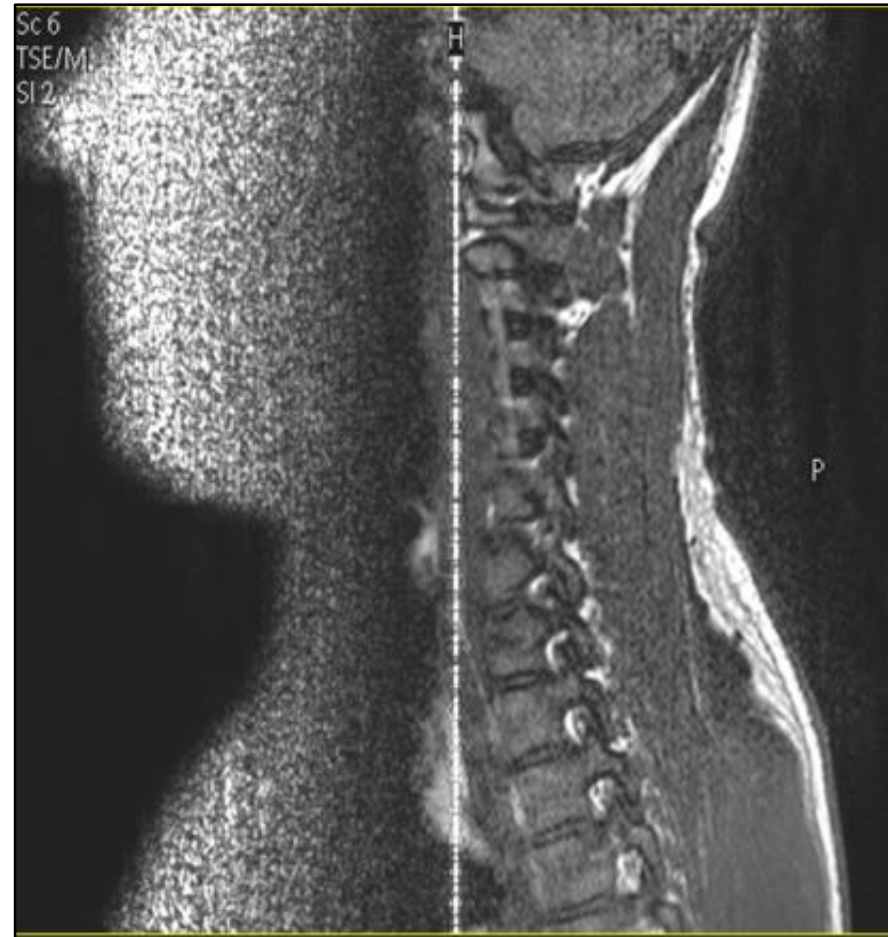
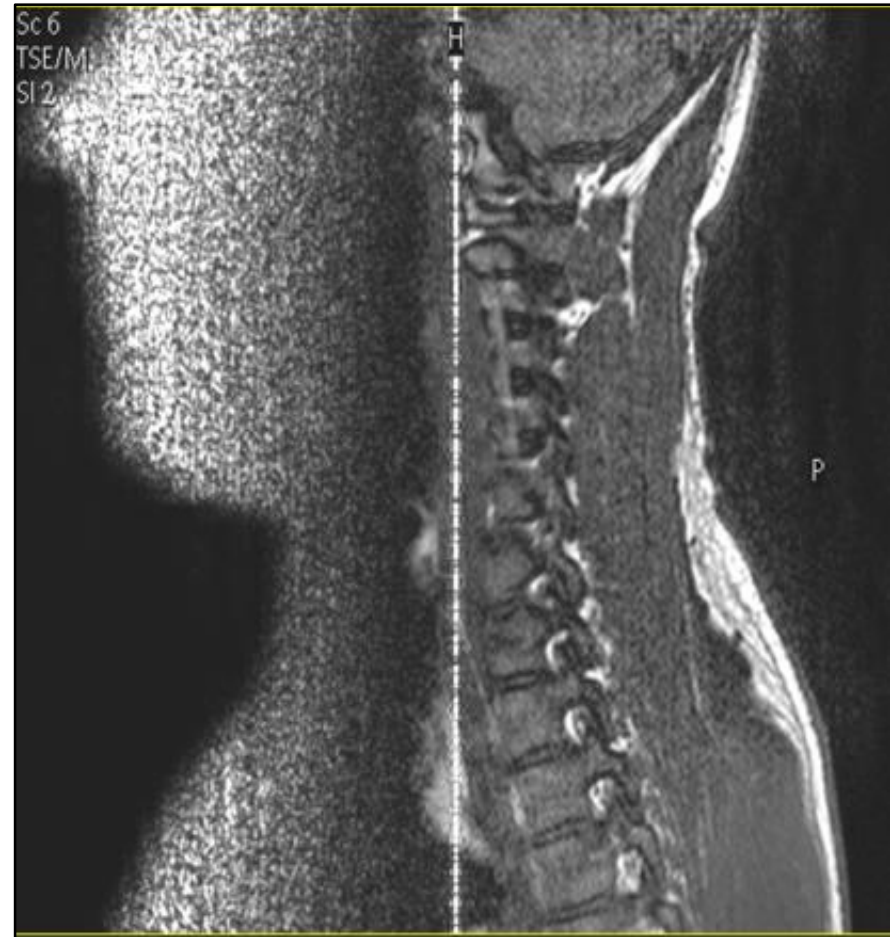
RF Interference

Cause:

- Defective filter in gradient cables

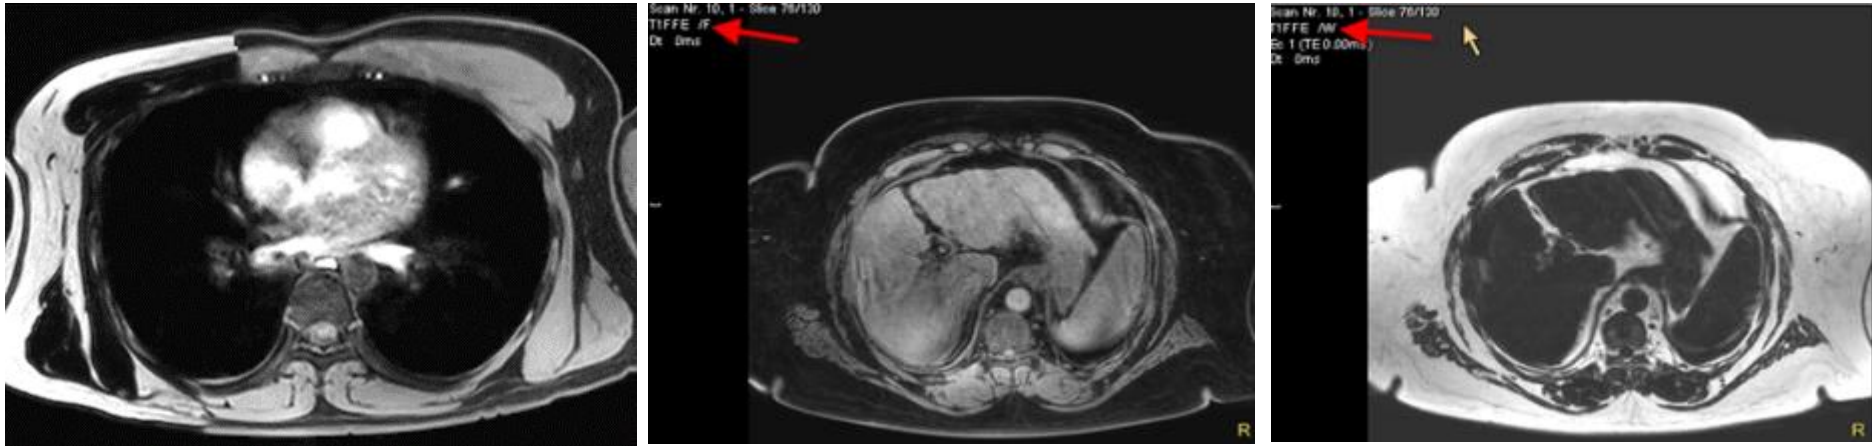
Reconstruction artifact

Swap artifact in mDIXON-FFE caused by incorrect calculation of Water and Fat reconstructions

- mDIXON_XD solve this problem, using 7 point fat modeling for better fat determination
